The Royal Trails Subdivision is located in northeast Lake County and lies along the northwest of State Road 44. The project is located within the St. Johns River Water Management District and is mostly within the delineated Wekiva River Protection Area boundaries. The approximately 3000+ acre subdivision (~5 square mile project area) has rural style drainage systems comprised of roadside swales, cross-drains, and outfall ditches. The study area has varied topography and numerous lakes, wetlands, and depression areas which make floodplain assessment a challenge. The subdivision boundary extends across several drainage basins and has multiple outfalls.

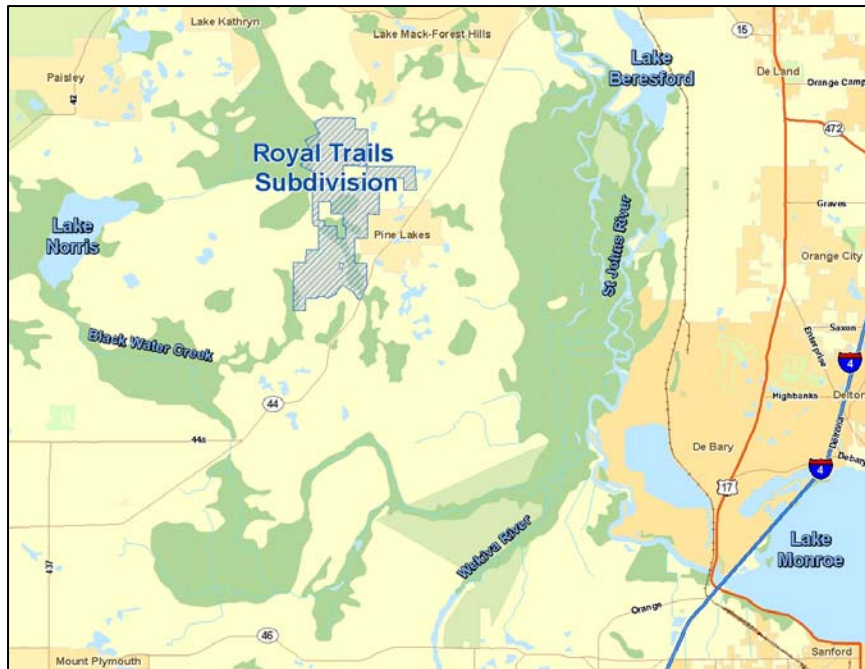
The second task was a Flood Assessment. During this task, a hydrological & hydraulic stormwater model was developed for the subdivision in order to delineate the 100-year frequency floodplains for the project area. In addition, the model was used to evaluate the level of service of the primary and secondary drainage systems in the subdivision to identify deficiencies.
